Case Study Jumpseat Training LLC

Citizens Fire Company
Independence Fire Company
February 3 2015

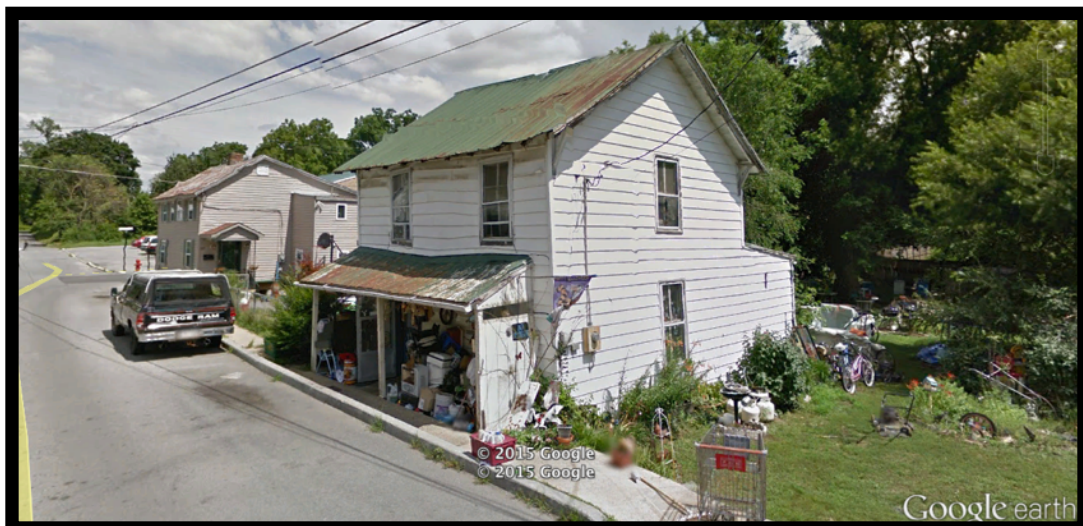
Figure 2 Conditions before Fire

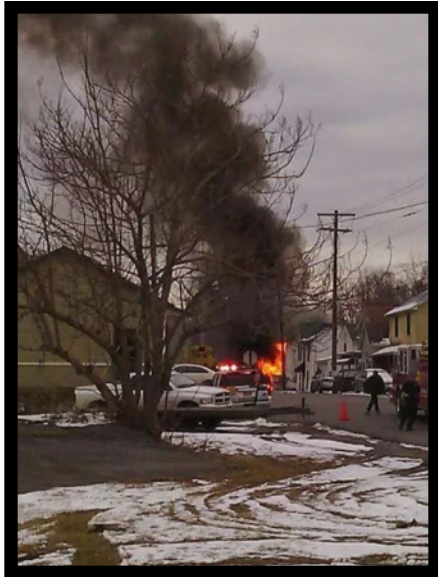
Figure 3 Arrival conditions

On February 3rd 2015 the Citizens Fire Company was dispatched to a working fire with confirmed victims trapped. First arriving companies found a two story balloon frame construction with Heavy Content Conditions and multiple victims.

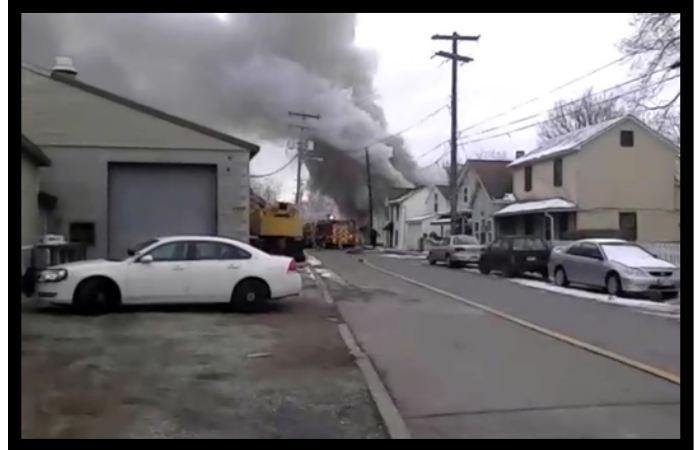
Figure 4 E 4-1 Layout

- Layout Hydrant
- Positioned A/D Corner
- Deployed 1 3/4 attack line

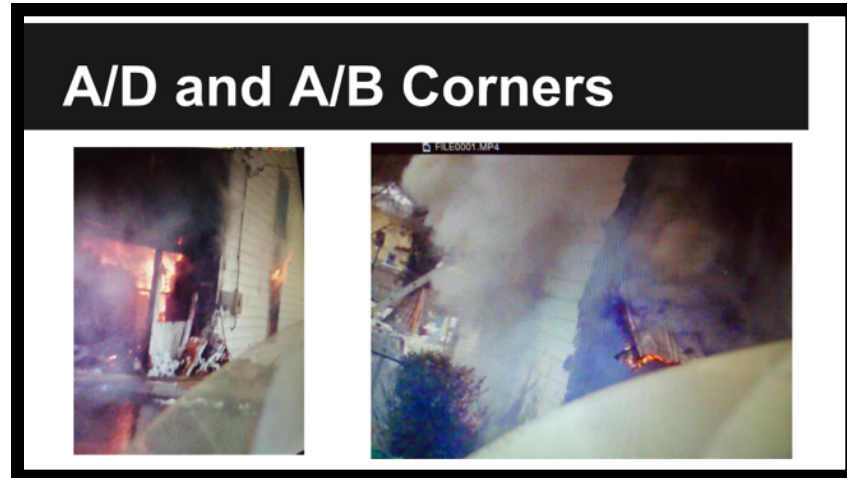
Figure 5 Room of Occupant

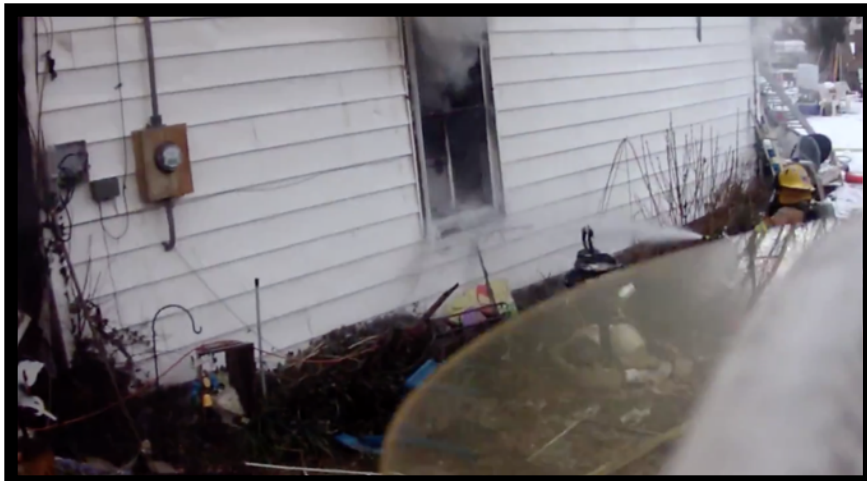
Figure 6 Fire conditions in victim room

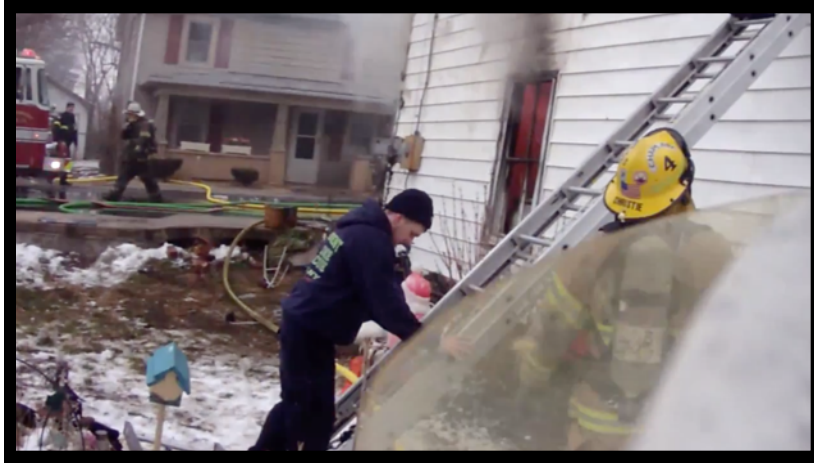
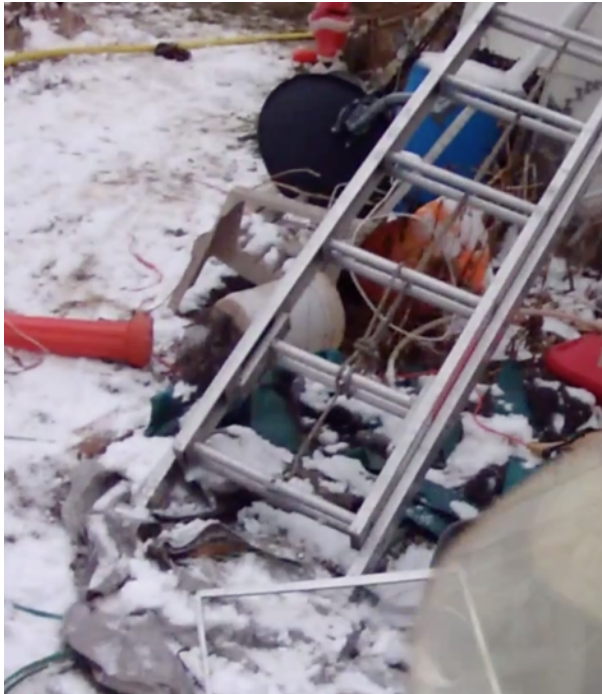
Figure 7 Ladder Hazard
