Case Study Jumpseat Training LLC

Citizens Fire Company
Independence Fire Company
February 3 2015

Introduction

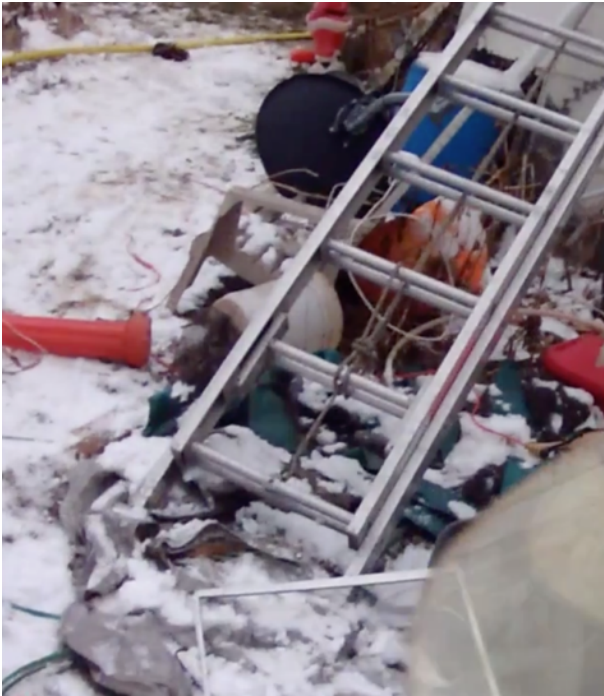
Figure 7 Ladder Hazard
