## CASE STUDY

**Event Date:** January 18, 2015

**Event Type:** Working Structure fire with Victim Trapped

**Location:** Skylark Court Elyria Ohio

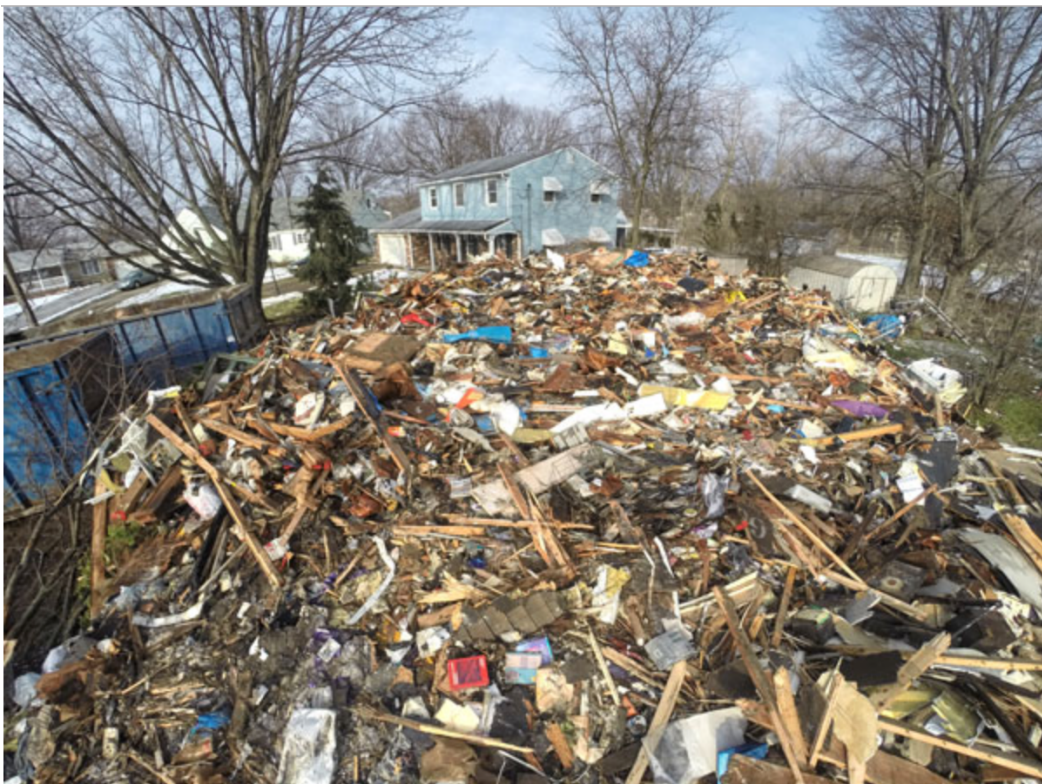
*Photo Credits [chronicle.northcoastnow.com](http://chronicle.northcoastnow.com)*

Overhaul and building demolition continued for hours and the aftermath is beyond words.

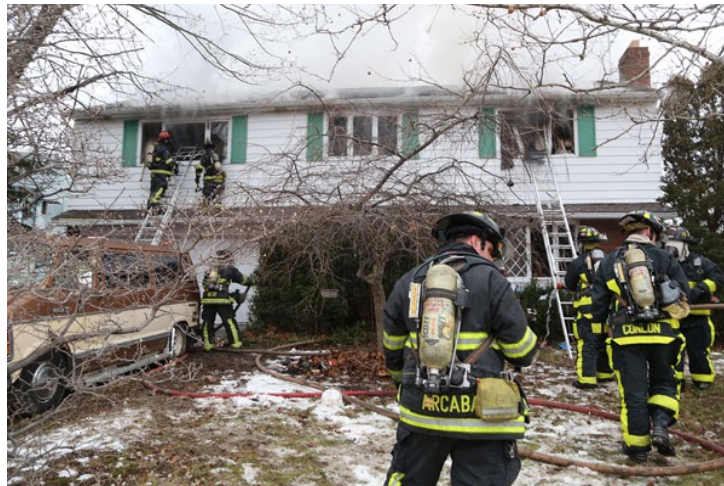
*In the above picture you can see the challenges faced by the firefighters trying to perform a Vent Enter Search procedures. Notice the high stacks of clutter visible from the exterior.*
